INCIDENT - PIA PERSONAL INJURY ACCIDENT  
PLYMOUTH RD & GREEN RD, ANN ARBOR MI

# STATE OF MICHIGAN TRAFFIC CRASH REPORT

CR No <b>250010950</b>	Subject <b>C3168 - Fatal - Pedestrian Traffic Crash</b>
Report Date/Time <b>03/11/2025 19:07</b>	Occurrence Date/Time <b>03/11/2025 19:07</b>
Location <b>PLYMOUTH RD&amp;GREEN RD</b>	Call Source <b>911</b>
Dispatched Offense <b>C3155 Personal Injury Traffic Crash PIA</b>	Verified Offense <b>C3168 Fatal - Pedestrian Traffic Crash</b>
OIC <b>Hoffman, Christopher (AAHOFFMANC-50802)</b>	OIC Contact Number
County <b>81 - Washtenaw</b>	City/Twp/Village <b>89 - Ann Arbor</b>
Division <b>Patrol - Nights</b>	
<b>Action Requested:</b>	
<input type="checkbox"/> Arrest warrant	<input type="checkbox"/> Review only
<input type="checkbox"/> Search warrant	<input type="checkbox"/> Forfeiture
<input type="checkbox"/> Juvenile petition	<input type="checkbox"/> Other

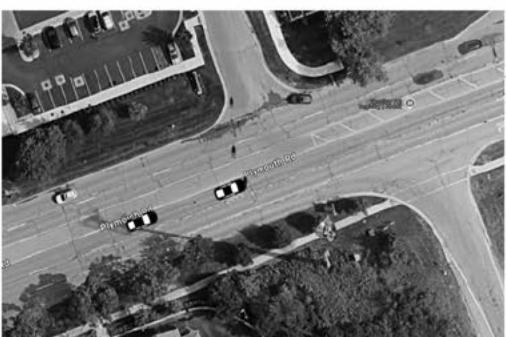
GVWR/GCWR <input type="radio"/> 10,000 lbs. or Less <input type="radio"/> 10,001 - 26,000 lbs. <input type="radio"/> Greater than 26,000 lbs.				Vehicle Configuration			Cargo Body Type	Medical Card		Hazardous Material <input type="radio"/> Hazard <input type="radio"/> Cargo Spill	ID #	Class #
	Owner Information				Owner Information								
	Witness Information				Witness Information								
					Age:								
	Investigated at Scene <b>Yes</b>	Reported Date (Time) <b>03/11/2025 (19:07)</b>	1st Investigator Name (Badge) <b>E SCHULTZ (157)</b>	2nd Investigator Name (Badge)			Photos <b>Yes</b>						
	Narrative <b>The driver of unit 1 was traveling in the E/B through lane on Plymouth Rd. Unit 1 was east of Green Rd approaching the S/B US-23 on ramp. A pedestrian was crossing Plymouth Rd walking S/B from the Plum Market parking lot. The pedestrian was not in a crosswalk and did not have the right of way. Unit 1 struck the pedestrian as they were crossing the roadway in front of them. The pedestrian was fatally injured as a result of the crash.</b>				Diagram
